Liverpool No.245 Restoration Progress Report

**LIVERPOOL 245 PROGRESS REPORT.
by TERRY MARTIN.**

OCTOBER 2012.

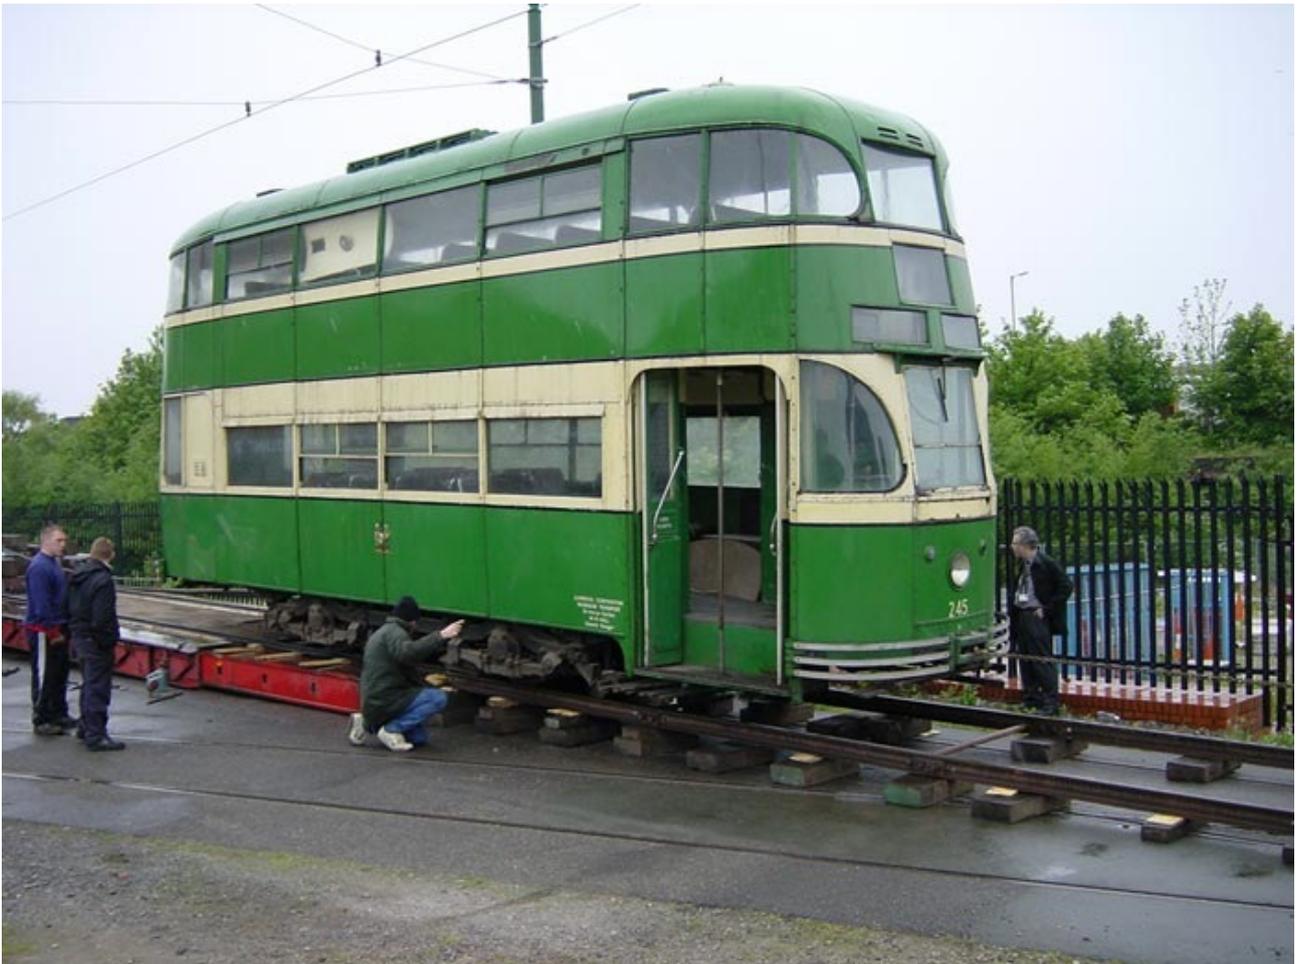
Securing a lottery grant of £50,000 took years to attain, with the o.k. finally coming in February 2010. In the meantime, Society volunteers had stripped down the car sufficiently to reveal widespread rot in the car's ash framework, which had been accelerated during the years of storage at the Steamport Museum in Southport. The tram had been stored directly below a badly leaking roof and rainwater had poured through the car in cascades. Many of the panels were dented, punctured or badly corroded, while the steel screws used throughout were rusted in place and very difficult to remove without damage to aluminium beadings etc.

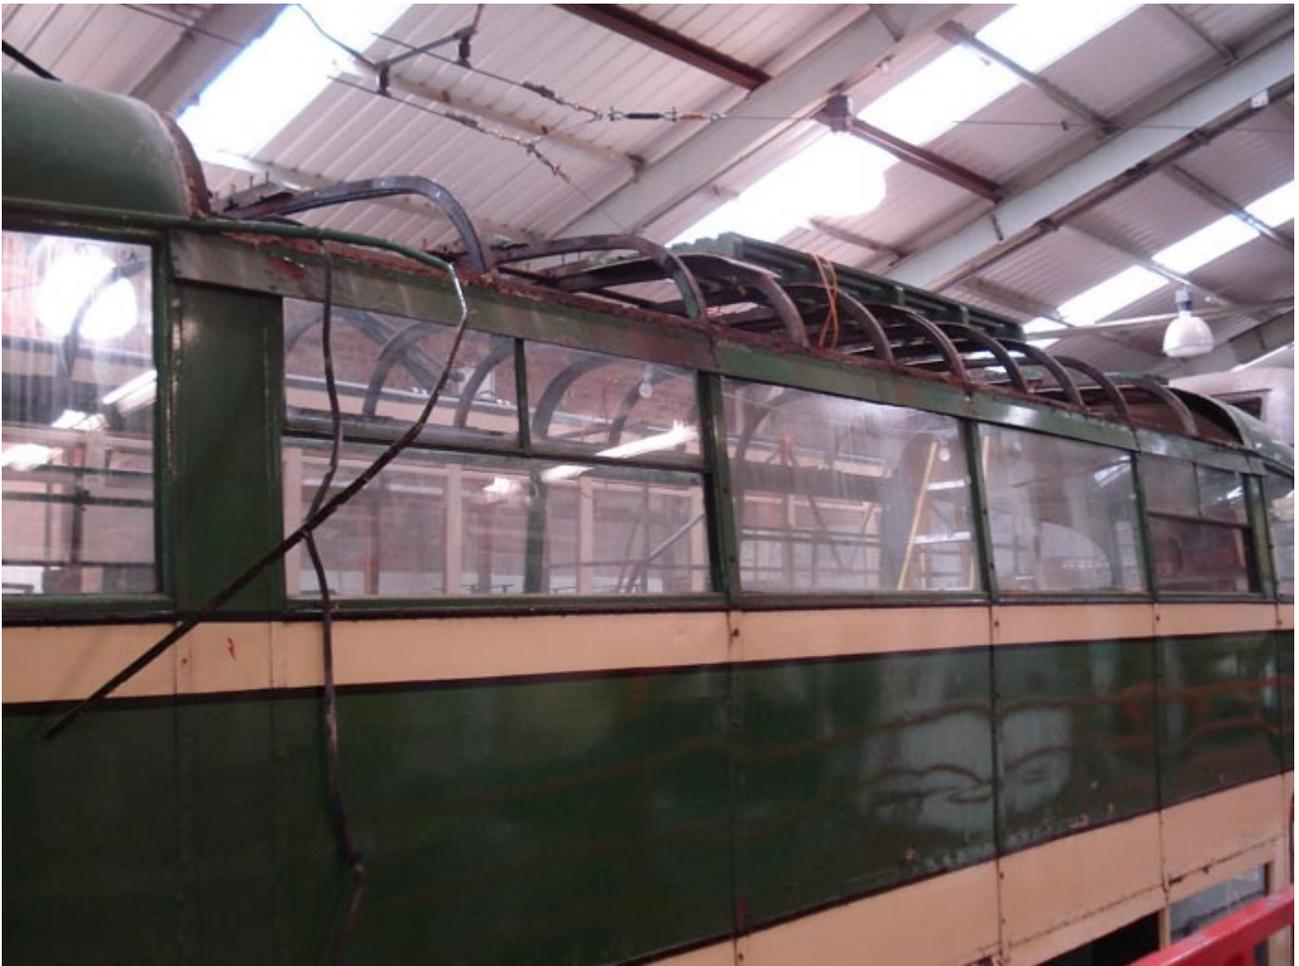
All of the plywood roof between the two domes was stripped away. Much of the ply had delaminated with damp. The ash roof sticks were mostly in sound condition, and after soaking in preservative were all re-used. The steel carlines were all derusted, and painted appropriately. Several new carlines were added near the middle of the roof to support the weight of the trolley base.

A large steel plate which fits to the lower side of the trolley plank and is bolted to the trolley base with large bolts passing through the ash trolley plank was replaced because of excessive rust disintegration. New marine grade plywood was fitted down the centre of the roof between the two domed ends. For the sharp curves bending to the sides of the tram, laminations of bendy ply was used. All of the wooden section of the roof was then covered with canvas fitted in the traditional way, using paint, and with metal beadings covering all the edges.

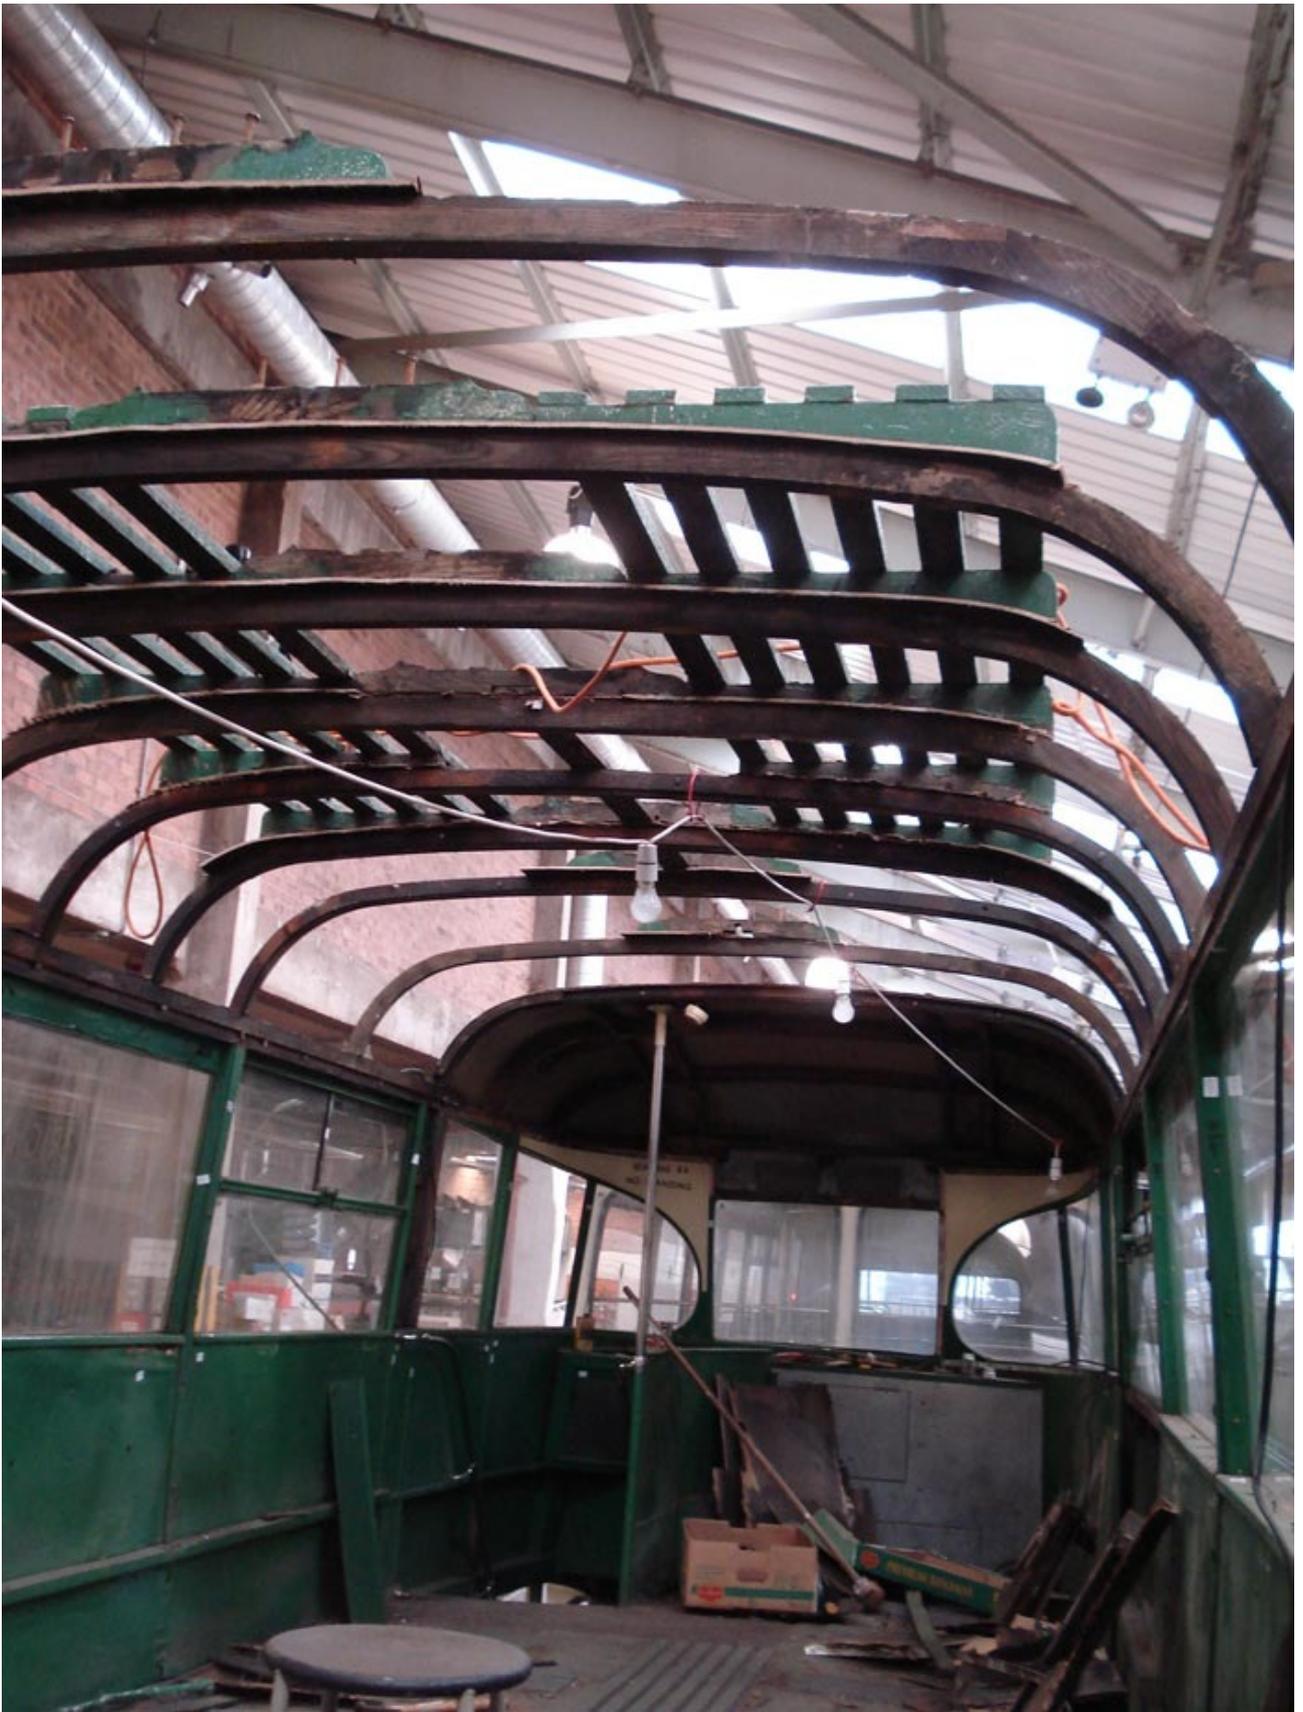
Throughout, the thick plywood and cork layer forming the upper saloon floor was generally in sound condition although water ingress had caused substantial rotting along its outer edges. This in turn had affected the ash cantrails running the length of the tram, and the pillars at almost all of the joints where they met. Replacing the cantrails and splicing in new ash to virtually all of the pillars was a major joinery feat. Thick new plywood sections were also installed along the floor edges. Sections of the ash seat rail also had to be replaced with new timber. Many of the interior plywood panels were rotted and removing rusted steel screws caused further damage. Consequently virtually all the side ply panels are new.

All the 16 curved ply ceiling panels were saved bar one which disintegrated through rot, and these were carefully treated with preservative. The original linen surface was retained and painted appropriately. The four 'canoe' shaped aluminium panels which fit on the ceiling at the domed ends were stripped of all corrosion (which meant losing their original linen) and new linen was carefully put back.

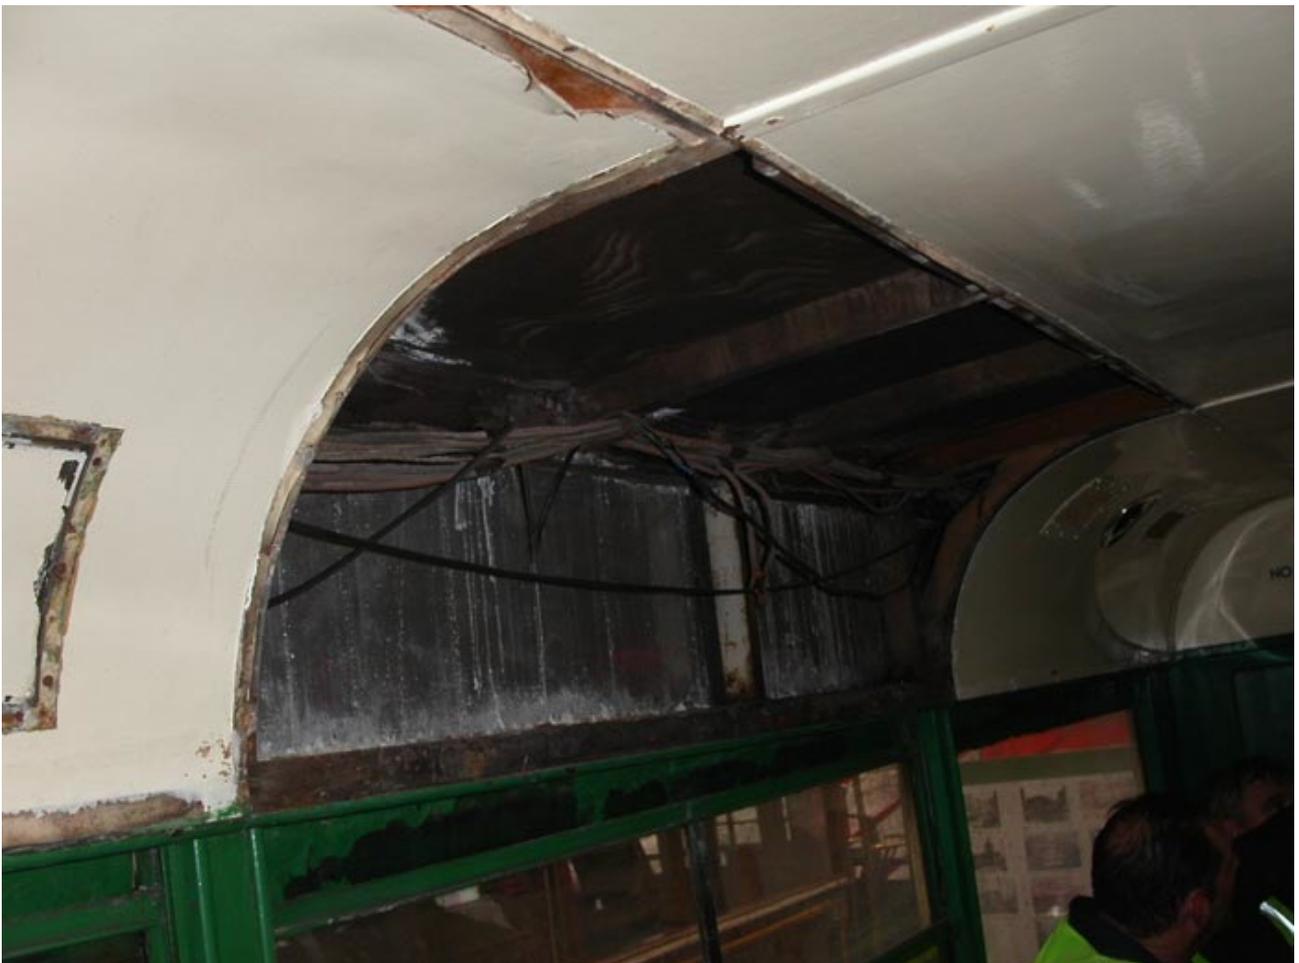
Around 'A' end, the intricately curved ash cantrail around the end of the tram was found to be rotted and this was carefully replaced with great difficulty. Around the staircase, rot was detected in the pillars and sills of the lower saloon windows and more ash was spliced in. On the upper deck, the sills of the D shaped end windows were badly rotted through rain ingress, and all had to be replaced with new ash hardwood.

The advertisement panels over the end windows were refurbished and put back, along with original restored beadings. All the seats were removed and the leather cushions and backs stored. The steel seat frames were shotblasted to remove all rust and old paint, and then painted in oxide and undercoat. The aluminium pedestals were carefully stripped down, painted in acid etch primer, and undercoat then stored ready for eventual fitting.

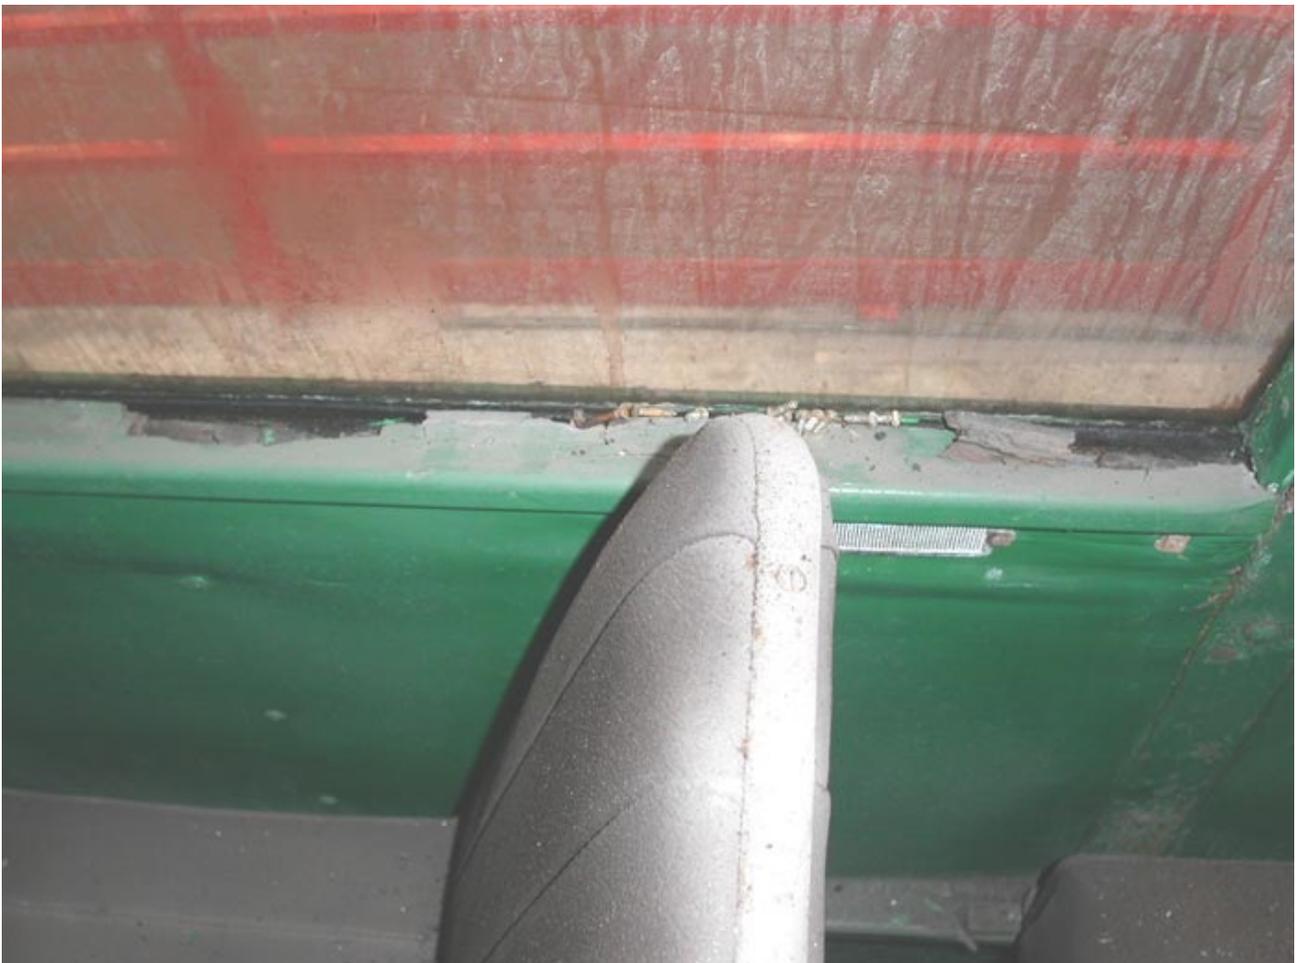
The three seized up winding mechanisms for the indicator blinds at this end of the car were removed, stripped down, derusted and cleaned out, and then reassembled in working order. Original 1950s indicators have been fitted to them. The indicator glazing was badly fitting with jagged edges and was replaced with 6 mm toughened

glass with smooth edges, set in a waterproof sealant and the original beadings.

The small cupboard on which the air pressure gauges are mounted below the left of the driving position, was stripped down and the gauges cleaned and tested. After some new ash was incorporated, the cupboard was reassembled as new.

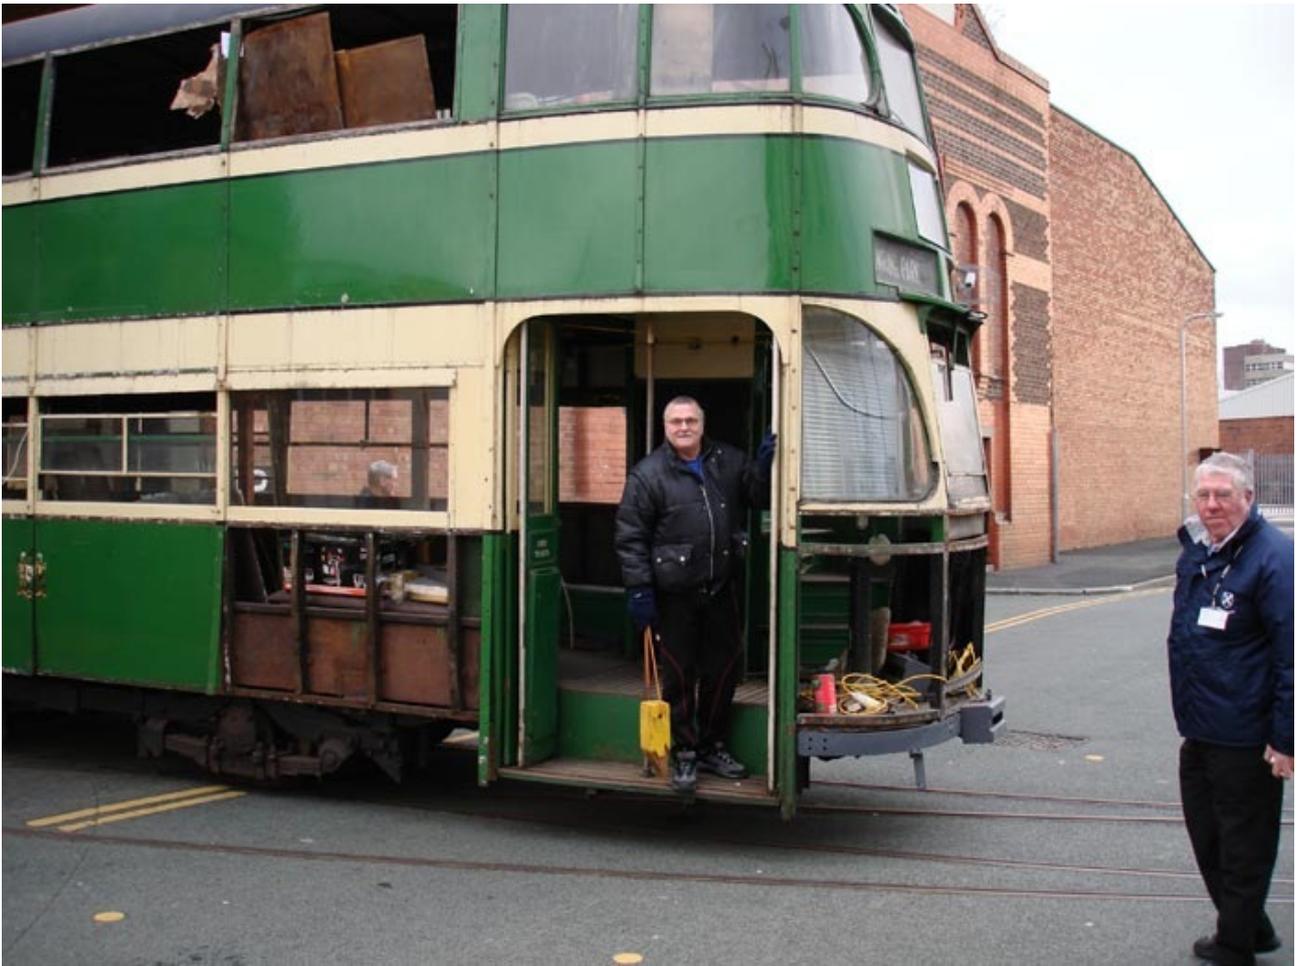
The step at 'A' end was found to have extensive rot and a new one was made and fitted. All the steel floor strips were gritblasted and re-used. This process is now being repeated at 'B' end of the car. The steel risers on both steps were stripped down for re-use and both were found to be carrying adverts for toothpaste under layers of green paint - obviously they had been cannibalised from other trams as an economy measure during 245's building in 1938, or fitted after subsequent accident damage.

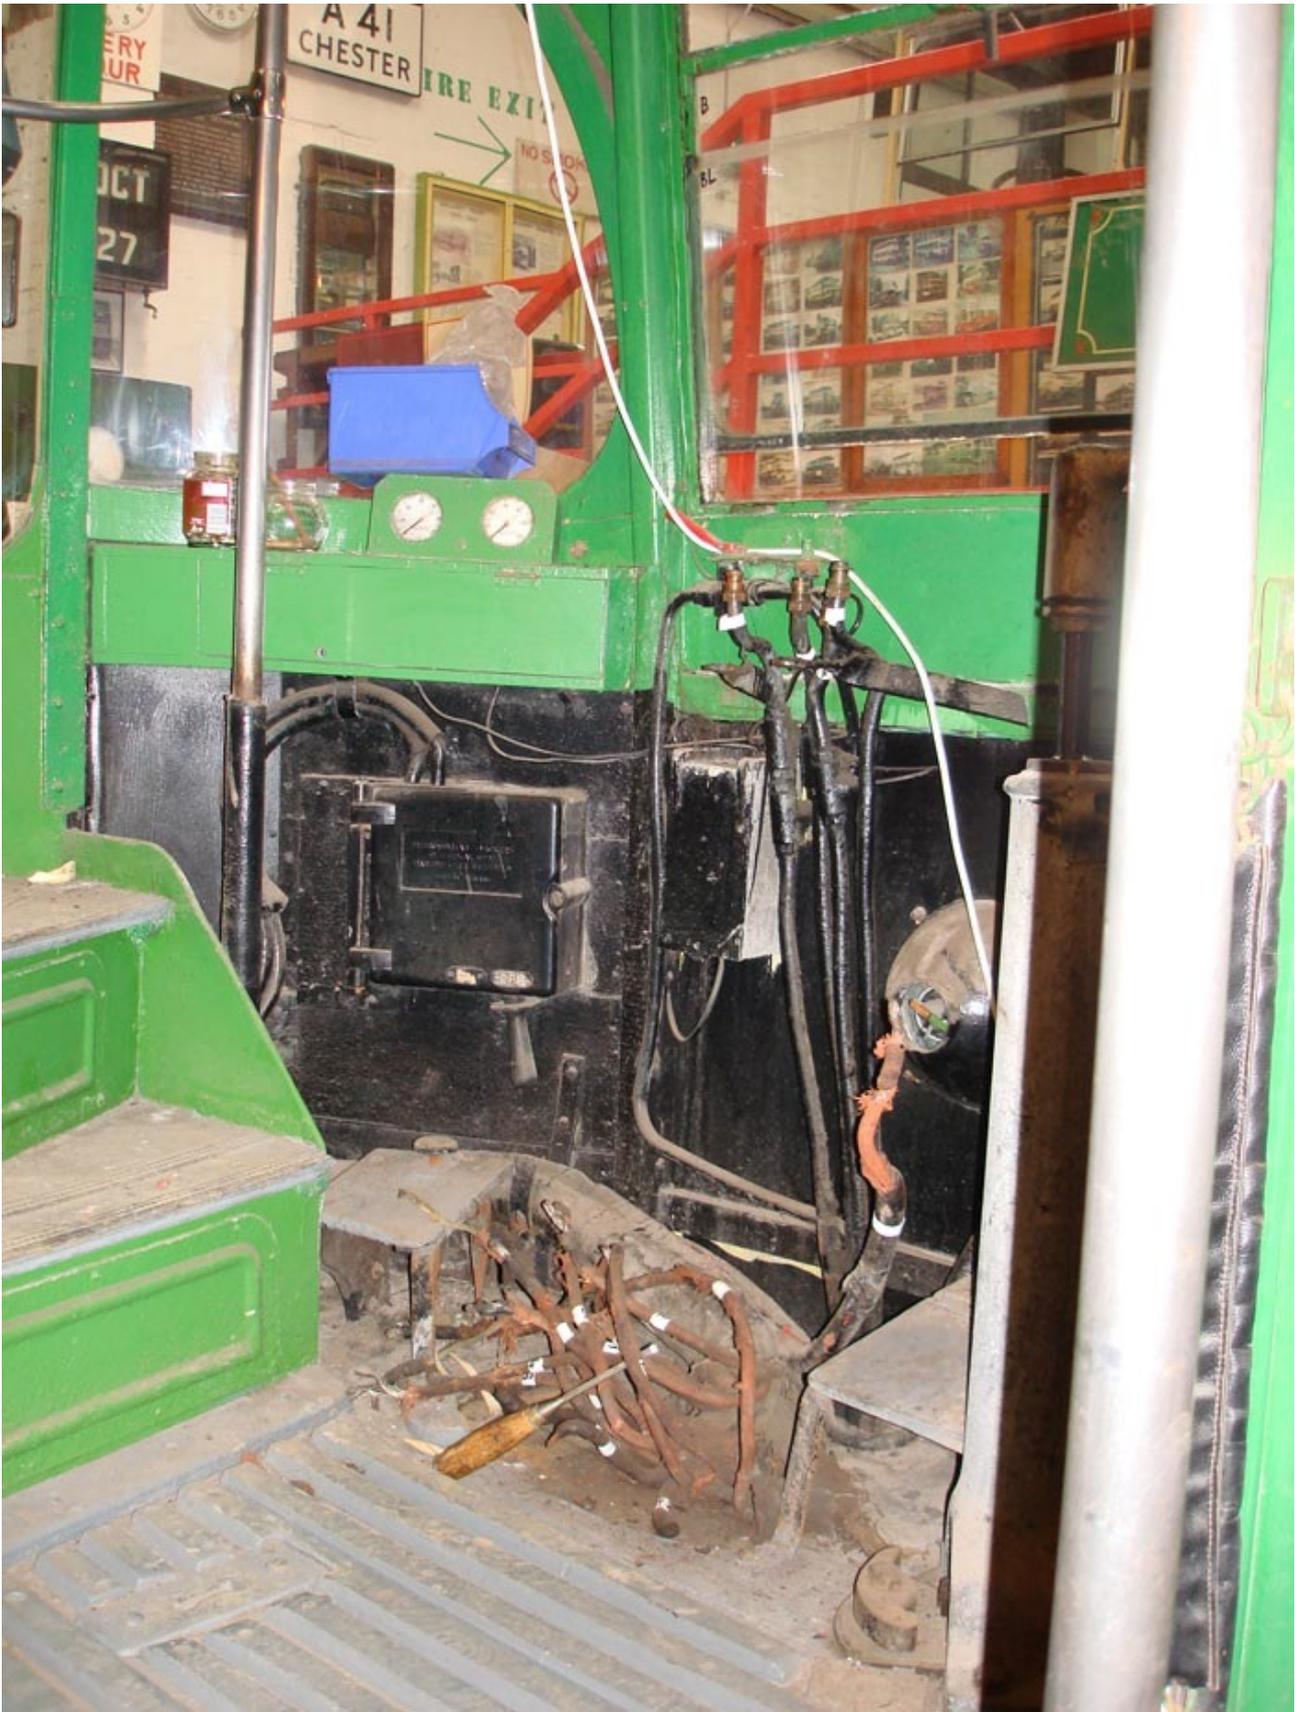
Rot on the lower deck sills at 'A' end resulted in a new ash sill for the windscreen, and a new curved sill for the D window next to the step. The same process is being carried out at 'B' end in the autumn of 2011. Low voltage wiring has been installed throughout the upper deck, and the bell wiring is also in place. Great care has been taken to keep traction cables (not yet fitted) and lighting wiring, as far apart as possible.

One of the controllers has been overhauled plus one of the handbrake columns. Their tops, match strikers/stubbers and platform warning bells have all been rechromed. The tram's two motors have been overhauled at a local firm, and it is hoped the truck will also be overhauled before the end of 2011. The tram's underframe has suffered badly over the years with rust and a number of heavy collisions which have buckled some of the steelwork. This too, will hopefully be addressed in the near future. All the pitchpine tongue and groove planking forming the lower saloon floor has been removed prior to this work being carried out.
